**2012 Remediation Effectiveness Report
for the U.S. Department of Energy
Oak Ridge Reservation,
Oak Ridge, Tennessee

Data and Evaluations**

Date Issued—October 2012

Prepared by the
Water Resources Restoration Program
URS | CH2M Oak Ridge LLC

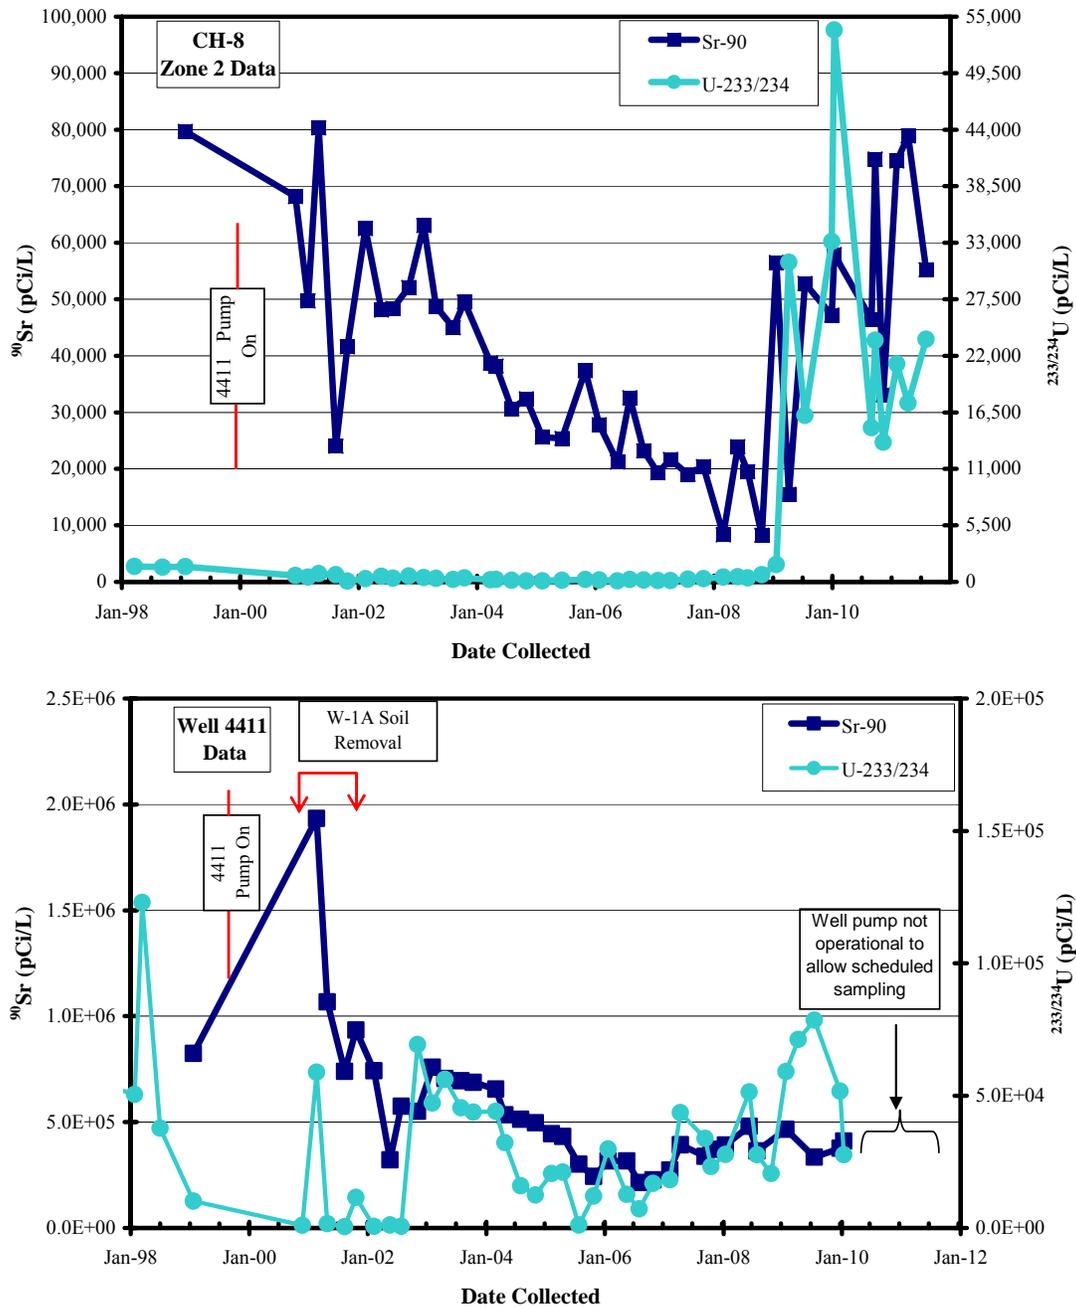
Figure 2.10. Contaminant activities in well 4411 and Corehole 8 Zone 2.

4411 are taken at the wellhead and represent contaminant concentrations in extracted groundwater that is being pumped to the Process Water Treatment Complex for treatment. Corehole 8 is a 50 feet deep well in which a Westbay® multizone sampling system was installed to allow sampling of discrete intervals in the well. Zone 2 is the second zone from the bottom of the well, and its sampling interval spans the depth of 41.2–43.2 feet below ground surface. During well installation and initial sampling, this zone was found to produce the highest activities of contaminants in the well and for that reason it has become the focal point for ongoing monitoring at that location. Data presented in Figure 2.10 show that during FY 2011 at Corehole 8, ⁹⁰Sr and ^{233/234}U activities remained high. Well 4411 was not operational during FY 2011 because of pump failure.

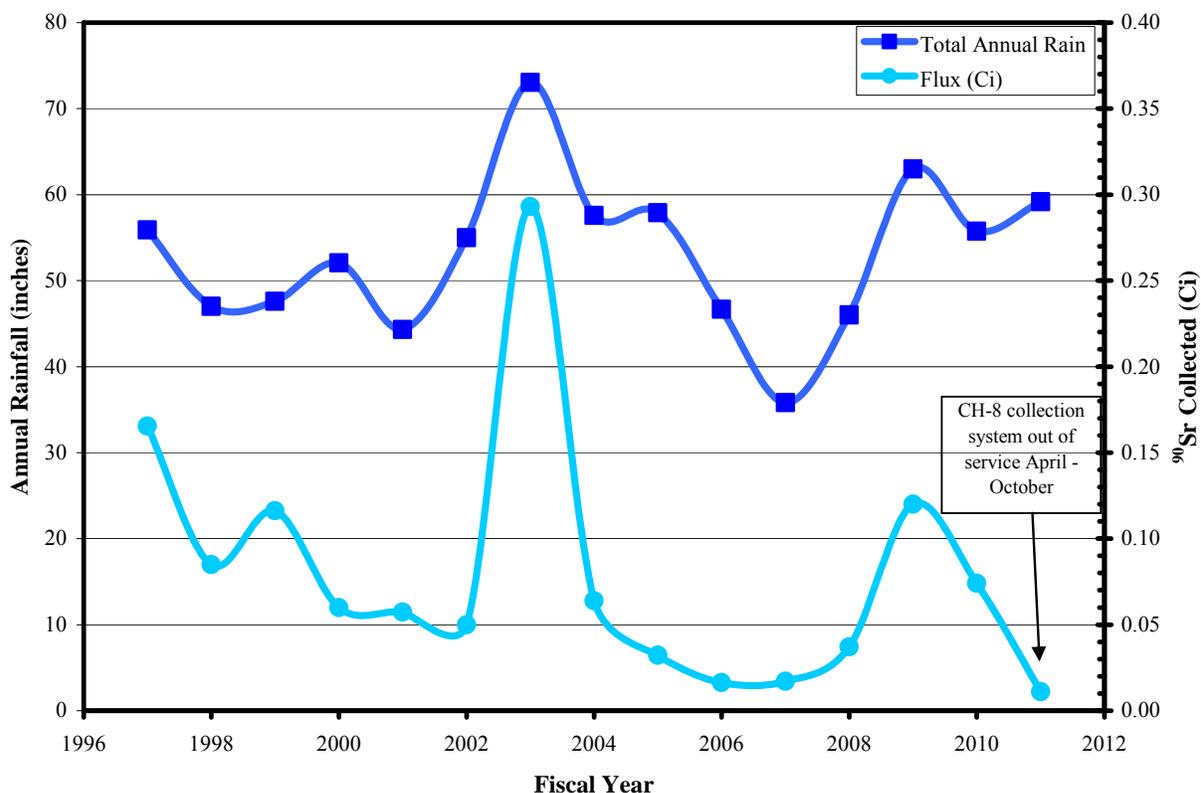
Figure 2.12. Corehole 8 Plume groundwater collector annual intercepted ⁹⁰Sr flux and rainfall.

Month	FY 1997			Month	FY 2011		
	⁹⁰ Sr (pCi/L)	Flow volume (liters)	⁹⁰ Sr flux (Ci)		⁹⁰ Sr (pCi/L)	Flow volume (liters)	⁹⁰ Sr flux (Ci)
October 1996	8700	933,000	0.0081	October 2010	625	2,309,587	0.001
November 1996	8800	1,845,000	0.0162	November 2010	1380	2,853,331	0.004
December 1996	7230	2,595,000	0.0188	December 2010	2070	2,176,920	0.005
January 1997	6890	1,711,000	0.0118	January 2011	3500	221,674	0.001
February 1997	8390	1,858,000	0.0156	February 2011	3170	147,125	0.0005
March 1997	7350	2,162,000	0.0159	March 2011	667	551,030	0.0004
April 1997	9870	1,946,000	0.0192	April 2011	—	0	—
May 1997	6750	1,697,000	0.0115	May 2011	—	0	—
June 1997	7280	2,631,000	0.0192	June 2011	—	0	—
July 1997	7463	1,705,000	0.0127	July 2011	—	0	—
August 1997	6647	1,131,000	0.0075	August 2011	—	0	—
September 1997	9465	953,000	0.009	September 2011	—	0	—
Total		21,167,000	0.1655	Total		8,259,667	0.011

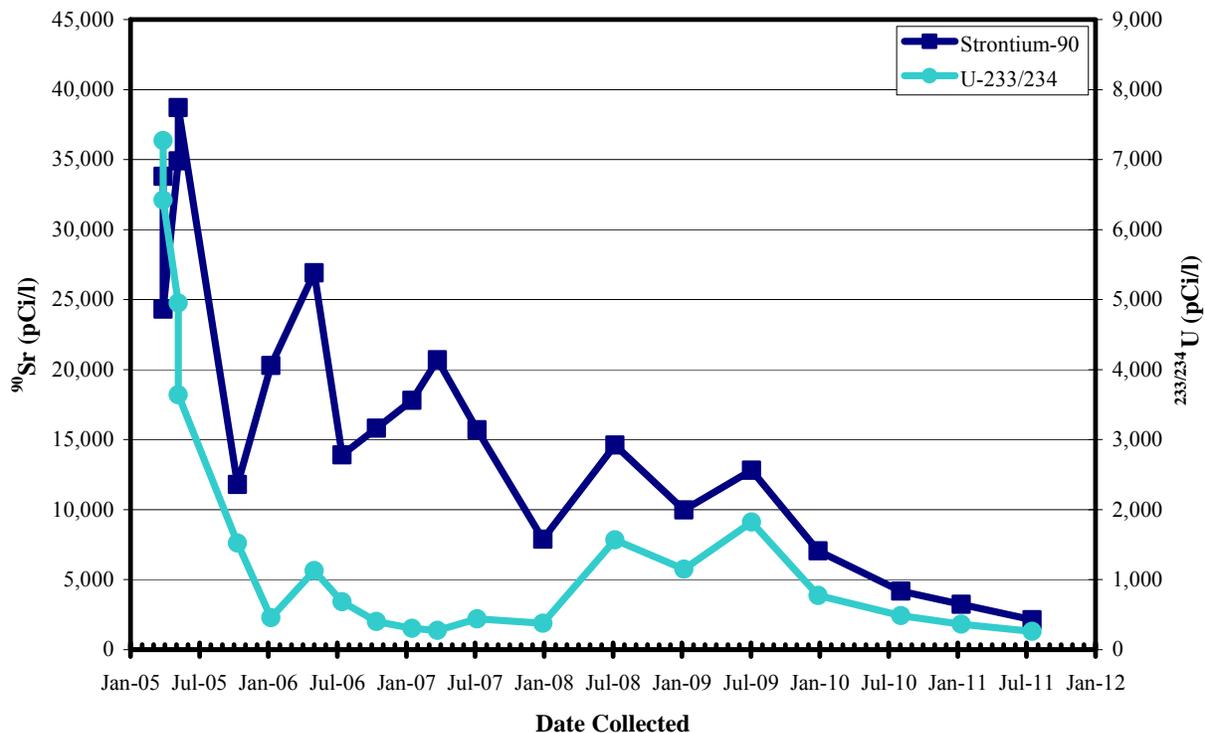
Figure 2.13. ⁹⁰Sr and ²³⁴U activities in well 4570.

Creek. Strontium-90 was not detected in well 4571 (9.7 feet deep) in either of two sampling events during FY 2011 and has not been detected since the start of monitoring in 2005. Strontium-90 was detected in well 4572 (48.8 feet deep) at 2.47 pCi/L in the January 2011 sample but was not detected in the August sample. The January 2011 detection of ⁹⁰Sr in well 4571 was the first unqualified detection since monitoring started in 2005.

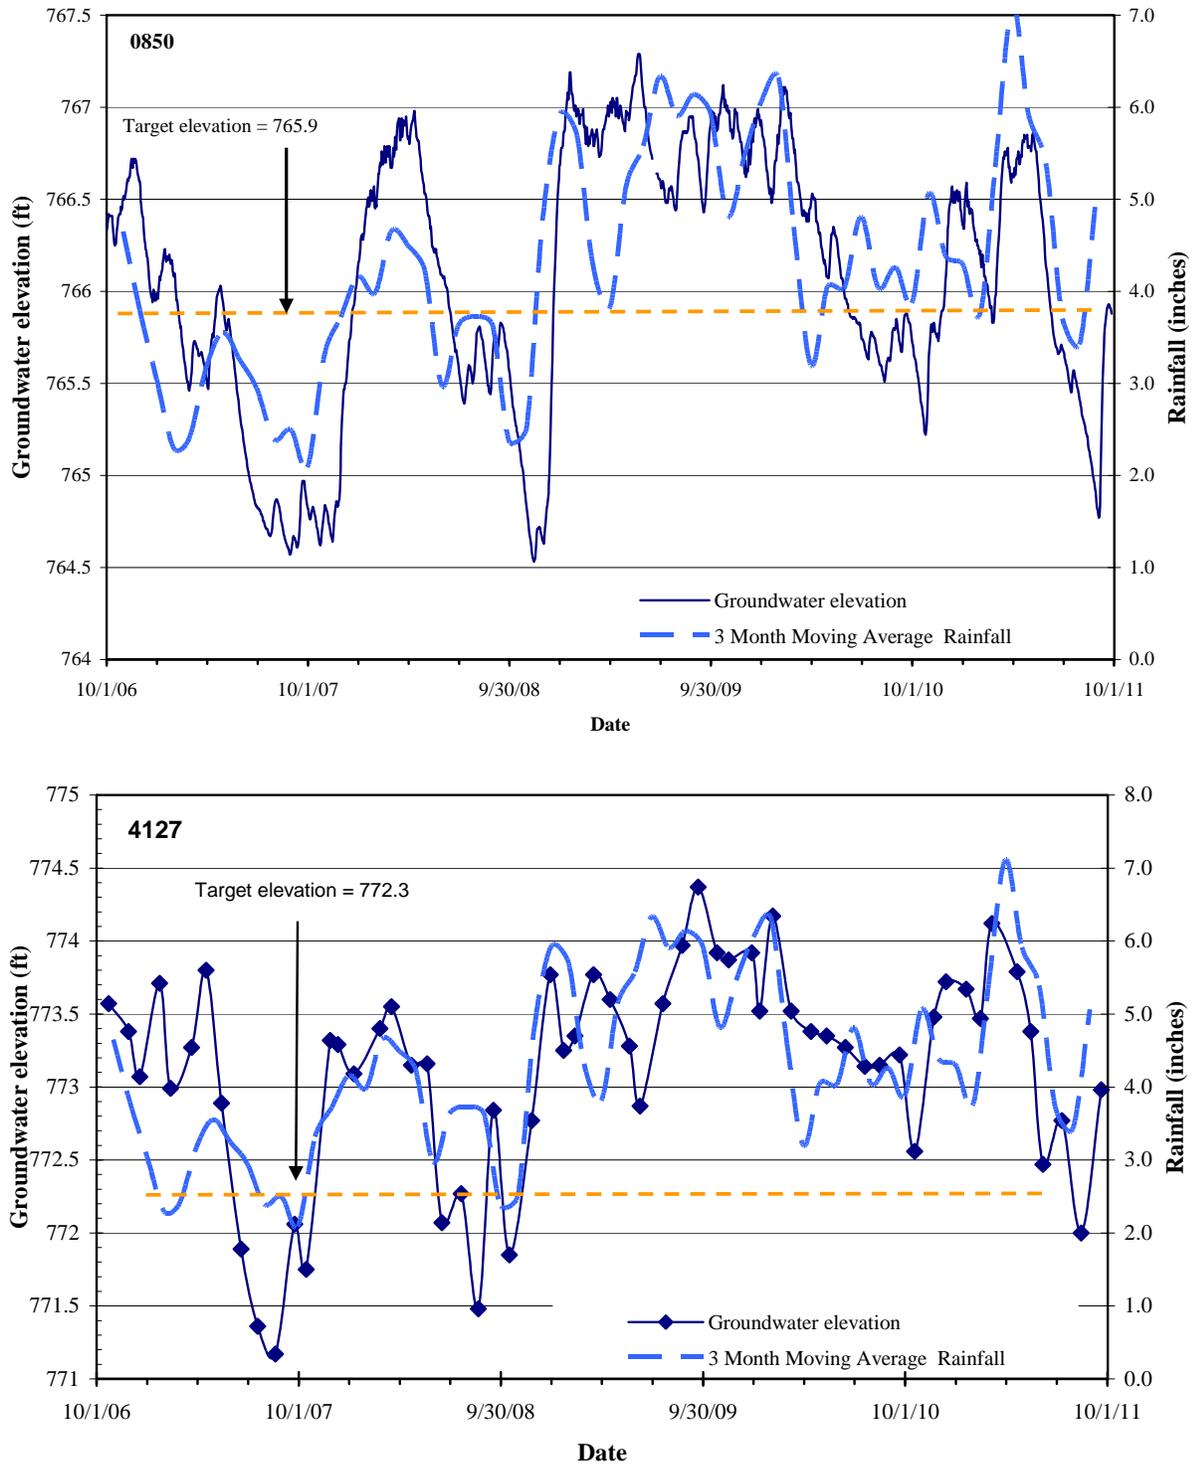
Figure 3.9. Hydrographs for wells 4127 and 0850 for FY 2007 through FY 2011.

Well 0850 is located in the central portion of Solid Waste Storage Area 6 in a former ravine area. The well extends approximately 13 feet below the estimated floor elevations of nearby waste burial trenches beneath the adjacent capped area. Water-level monitoring data indicate that during the wet season the groundwater level in the well rises above the target groundwater elevation. The hydrograph response for well 0850 (Figure 3.9) shows a muted response to rainfall events and a strong seasonal fluctuation signature suggesting that the well is responding to groundwater level variations caused by recharge to areas outside the capped area. As shown in Figure 3.9, the water level in well 0850 remained high through the summer of 2009 and into the summer of 2010 when levels again declined. Water quality data from well 0838, which is located downgradient from well 0850, was reviewed to determine if contaminant levels from that portion of Solid Waste Storage Area 6 are adversely affected by the groundwater levels near well 0850. VOCs are not detected at well 0838, nor are alpha and beta activity. ^3H is detected in well 0838, as it was in surface water from the area prior to remediation, and since FY 2004 the ^3H

concentrations have decreased exponentially from more than 200,000 pCi/L to less than 10,000 pCi/L. This decrease in ^3H concentration in this area is a continuation of tritium concentration reduction observed since about FY 2003 and suggests that the groundwater levels observed at well 0850 are not causing mobilization of contaminants from the area.

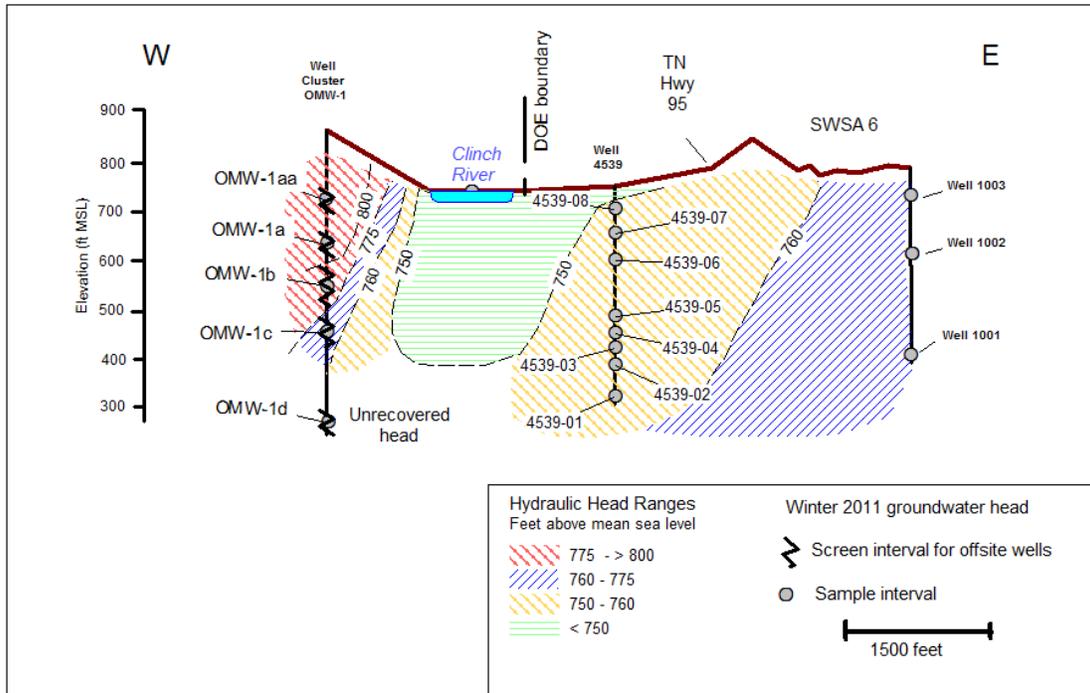
Figure 3.18. Hydraulic head cross section B.

pressure, and associated groundwater movement, translates through interconnected fractures mostly parallel to geologic strike in the bedrock and head pressure is relieved in the discharge area at the Clinch River. The zone beneath the Clinch River acts as a hydraulic sink, as depicted by the 750-foot hydraulic head contour which has higher head areas on both east and west sides.

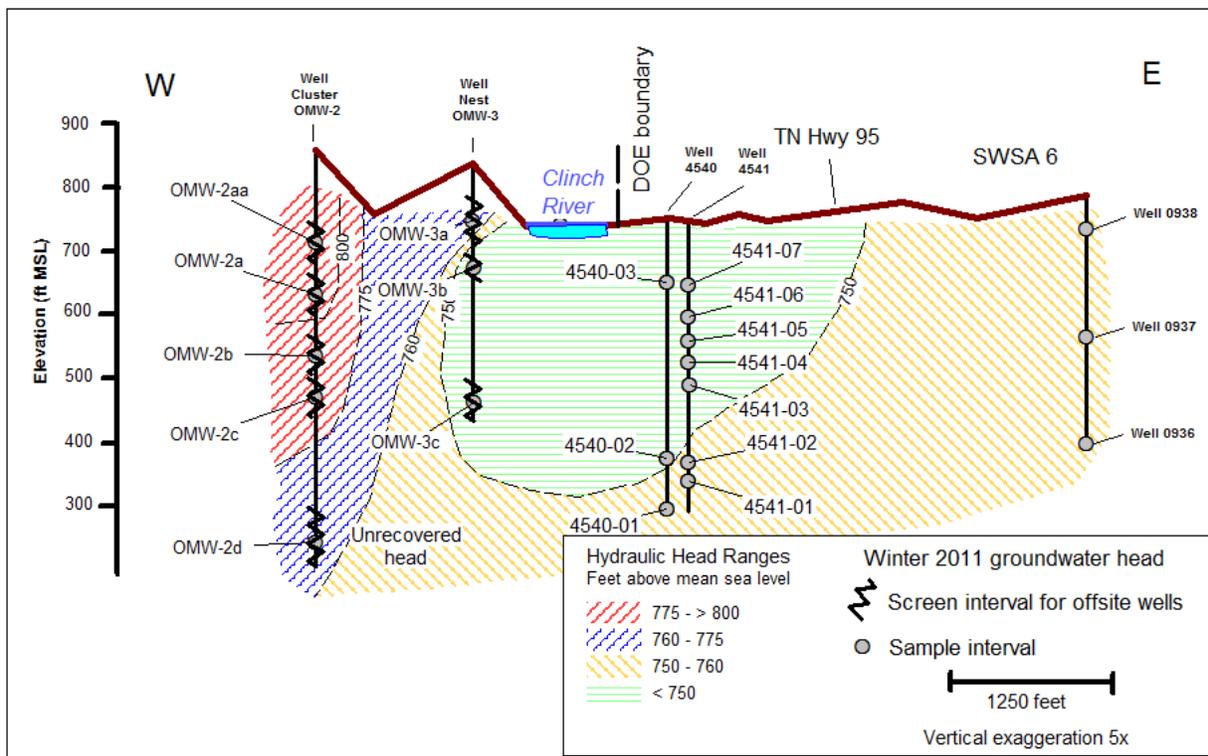
Figure 3.19. Hydraulic head cross section C.

River, the hydraulic head elevation increases gradually but does not reach the levels observed in Cross Section B at a similar distance east of the river. This more gradual gradient is attributed to the more subdued topography along the section line and the observation that groundwater enters bedrock fractures along this profile at lower head elevations than at the eastern end of Cross Section B. Similar to Cross Section B, that area beneath the Clinch River has lower hydraulic head than areas to the east and west, indicating groundwater discharges into the Clinch River from both sides.

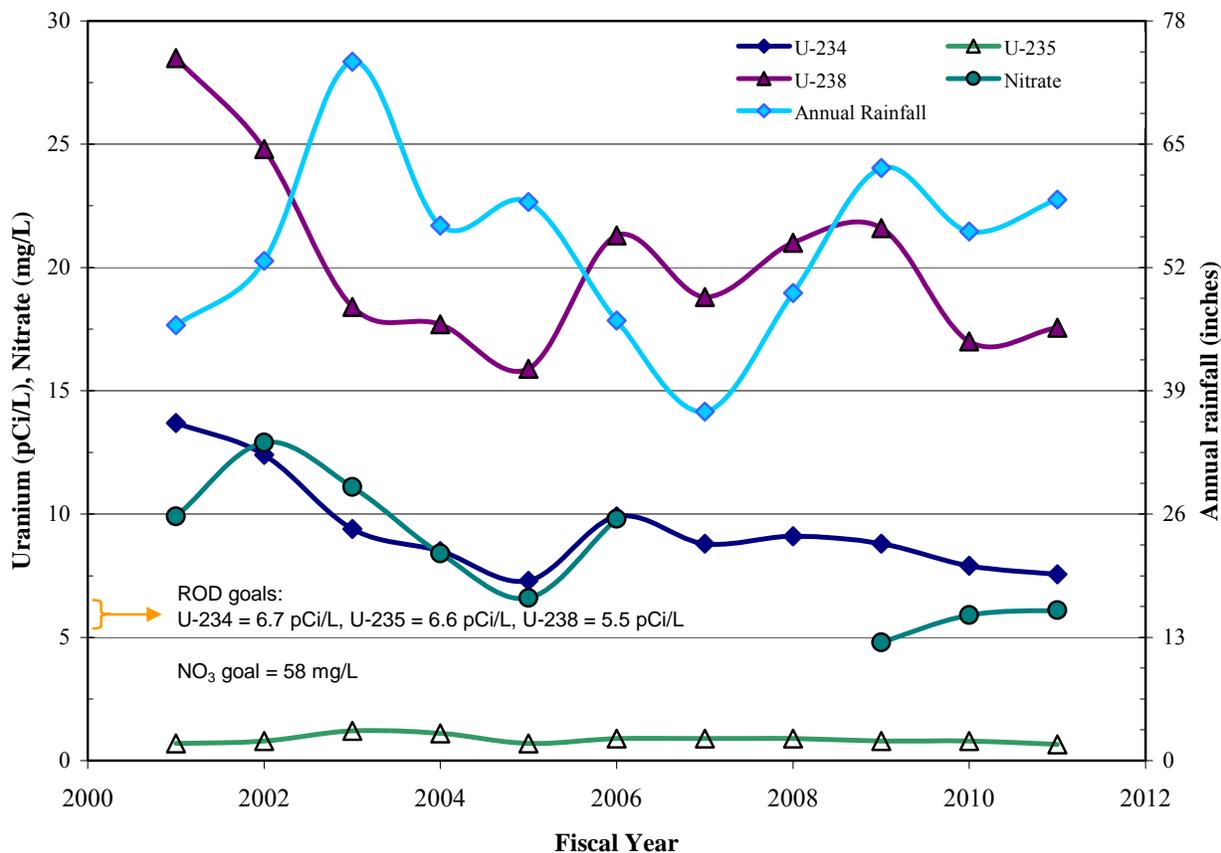
Figure 4.3. Average annual uranium isotope activity, nitrate concentration at Bear Creek kilometer 9.2, and annual rainfall.

near the S-3 source and decrease with distance downstream to the west. Table 4.7 shows the average concentration of nitrate at BCK 9.2 for years since the Record of Decision was implemented. Figure 4.3 shows the average nitrate concentration in surface water at BCK 9.2 along with the annual average rainfall.

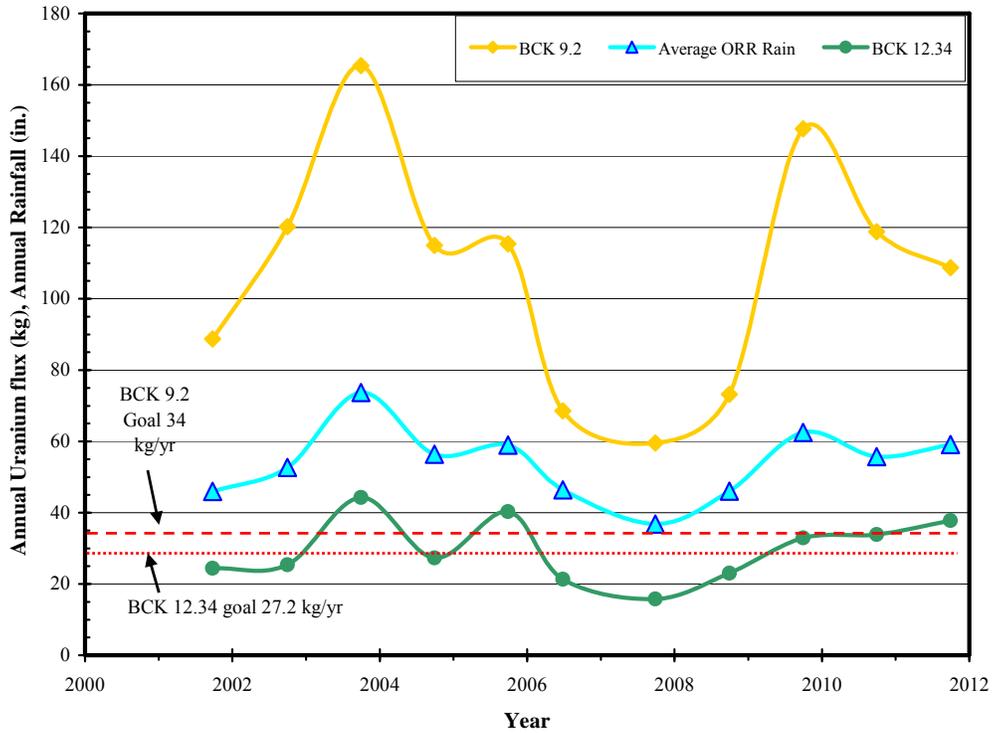
Figure 4.4. Post-Record of Decision uranium flux at BCK 9.2 and BCK 12.34 and annual rainfall.

Review of Figure 4.4 shows the relationship between rainfall and total uranium flux at BCK 9.2 and BCK 12.34. The amount of uranium that is mobilized from buried waste sources and residual groundwater contamination in the S-3 Pond area depends on the amount of rainfall that occurs. Increased rainfall causes increased groundwater recharge, more leachate, higher groundwater levels, and more contaminant transport from buried/below-grade sources to the streams. The relationship between annual rainfall and annual uranium fluxes measured at BCK 9.2 and BCK 12.34 is strongly linear during the post-Record of Decision monitoring period, as demonstrated in Figure 4.5. The higher mass flux and the greater positive slope of the trend at BCK 9.2 than at BCK 12.34 reflect the presence of a significant uranium source that enters Bear Creek between the two stations. During FY 2007, data collection indicated that NT-8 was a significant contributor of uranium to Bear Creek and continuous flow-paced monitoring of NT-8 started in FY 2008. During FY 2011 monitoring of NT-8 documented that about 40 kg of uranium was discharged directly to Bear Creek (Table 4.8).

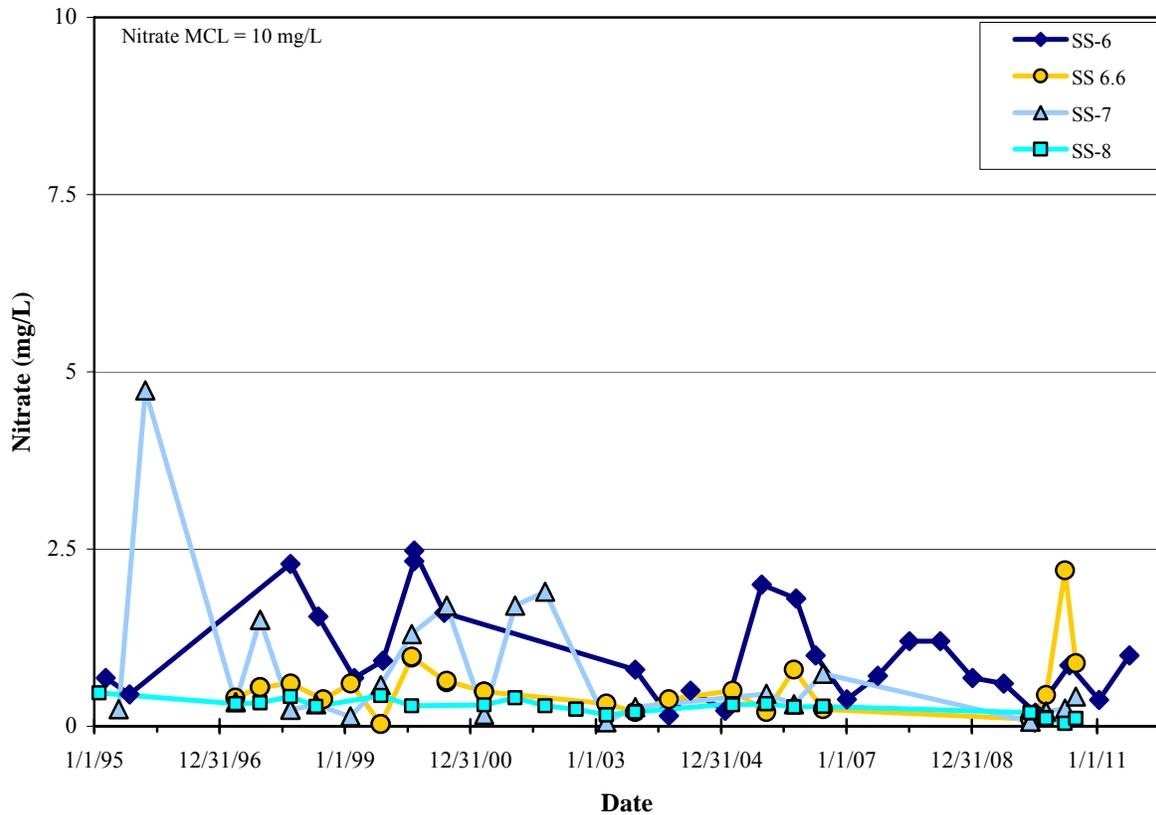
Figure 4.9. Nitrate concentrations in Zone 1 springs.

Analyses conducted since FY 2000 show the occasional presence of very low levels of ⁹⁹Tc in the springs. Like nitrate, ⁹⁹Tc is a signature contaminant that originates from the S-3 Ponds releases. The levels of ⁹⁹Tc measured in the Zone 1 springs are in the range of 10 – 30 pCi/L, which are approximately 1% of the maximum contaminant level effective dose equivalent activity of 900 pCi/L. The majority of ⁹⁹Tc results are non-detect and nearly all the results that suggest the presence of ⁹⁹Tc are qualified as estimated values because the measured activities are very close to the detection limits. While ⁹⁹Tc was not detected in spring SS-6 samples in FY 2011, beta activity was detected at 4.01 and 5.91 pCi/L in January and July, respectively.

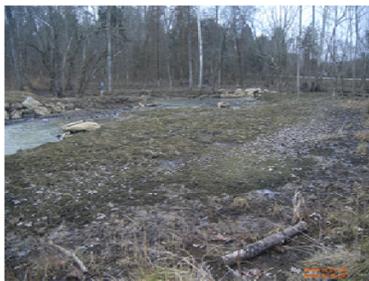
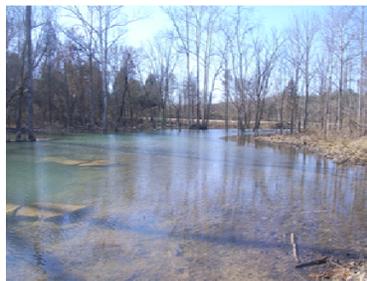
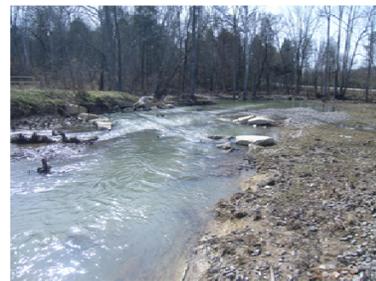
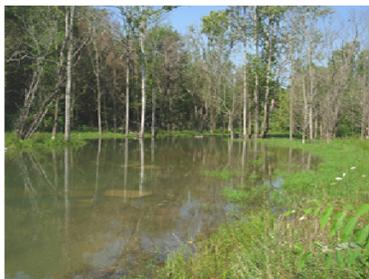
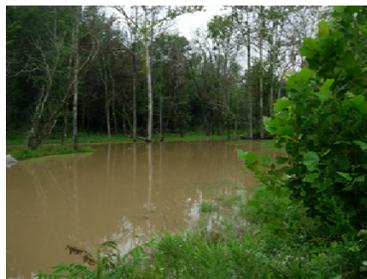
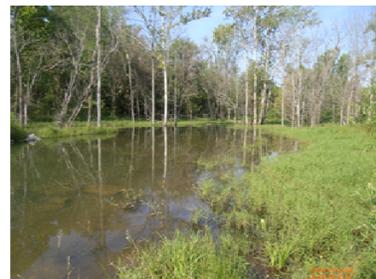
Figure 4.21. Photographic series depicting changes in water levels at constructed area of Bear Creek, FY 2011.

The five year quantitative monitoring program for this site ended in 2010. An Appendix I-12 letter has been sent to EPA and TDEC seeking formal approval (included as an Issue Carried Forward from the 2011 Remediation Effectiveness Report in Table 4.14). However, visual surveys were conducted in FY 2011 because of dramatic changes to the hydrology of the mitigation site. In January 2011, the existing beaver dam at the site was breached, and the ponded area at the site was completely drained. This changed the character of the site and restored near-previous stream flow patterns for a short period of time. However, there were continued signs of beaver in the area including tracks, cuttings, bark stripping and slides. Fresh tracks and belly marks were also observed at the entrance to the existing beaver lodge. Tracks were also noted around the area of the dam breach, indicating that beaver were actively trying to make repairs to the dam. Actual repairs to the dam breach were noticeable by early February. However, a significant rain event in early March caused another blowout in the dam. Based on routine observations made at the site following that breach it appeared that beaver had abandoned the site for an extended period of time. During this time period no tracks, slides, feeding or damming activities were noted at the site. Sometime in early June beavers reoccupied the site and dam reparations were being made. By the end of June much of the site was once again flooded. A mid-July significant rain event did not cause a breach in the dam and the area remained flooded through August, creating habitat conditions similar to those in existence prior to the January breach. Figure 4.21 is a series of photographs that depicts water level changes in the constructed section of Bear Creek in 2011.

January 27, 2011 (following dam breach)

February 10, 2011 (beavers rebuild dam)

March 2, 2011 (dam blowout after rain event)

June 30, 2011 (beavers rebuild dam)

July 15, 2011 (beaver pond after rain event)

August 11, 2011 (beaver dam remains intact)

Visual surveys were conducted in FY 2011 in an effort to evaluate major changes to site hydrology. Although the site underwent a significant transformation as the result of beaver activity, impacting originally intended mitigation plans, this did not prevent the development of the area into a viable and productive natural community. Beavers are endemic to the area and play an important role in the natural evolution toward the establishment of diverse riparian habitats on the Oak Ridge Reservation. Beaver are particularly well-known inhabitants of the Bear Creek Valley where they are seen in varying numbers up and down the watershed, dependent on local food availability and normal cycles in colony sizes. The various changes in hydrology evident in Figure 4.21 are part of the natural environment and are not deemed to be related to the mitigation design or actions. No further monitoring of the site will be conducted.

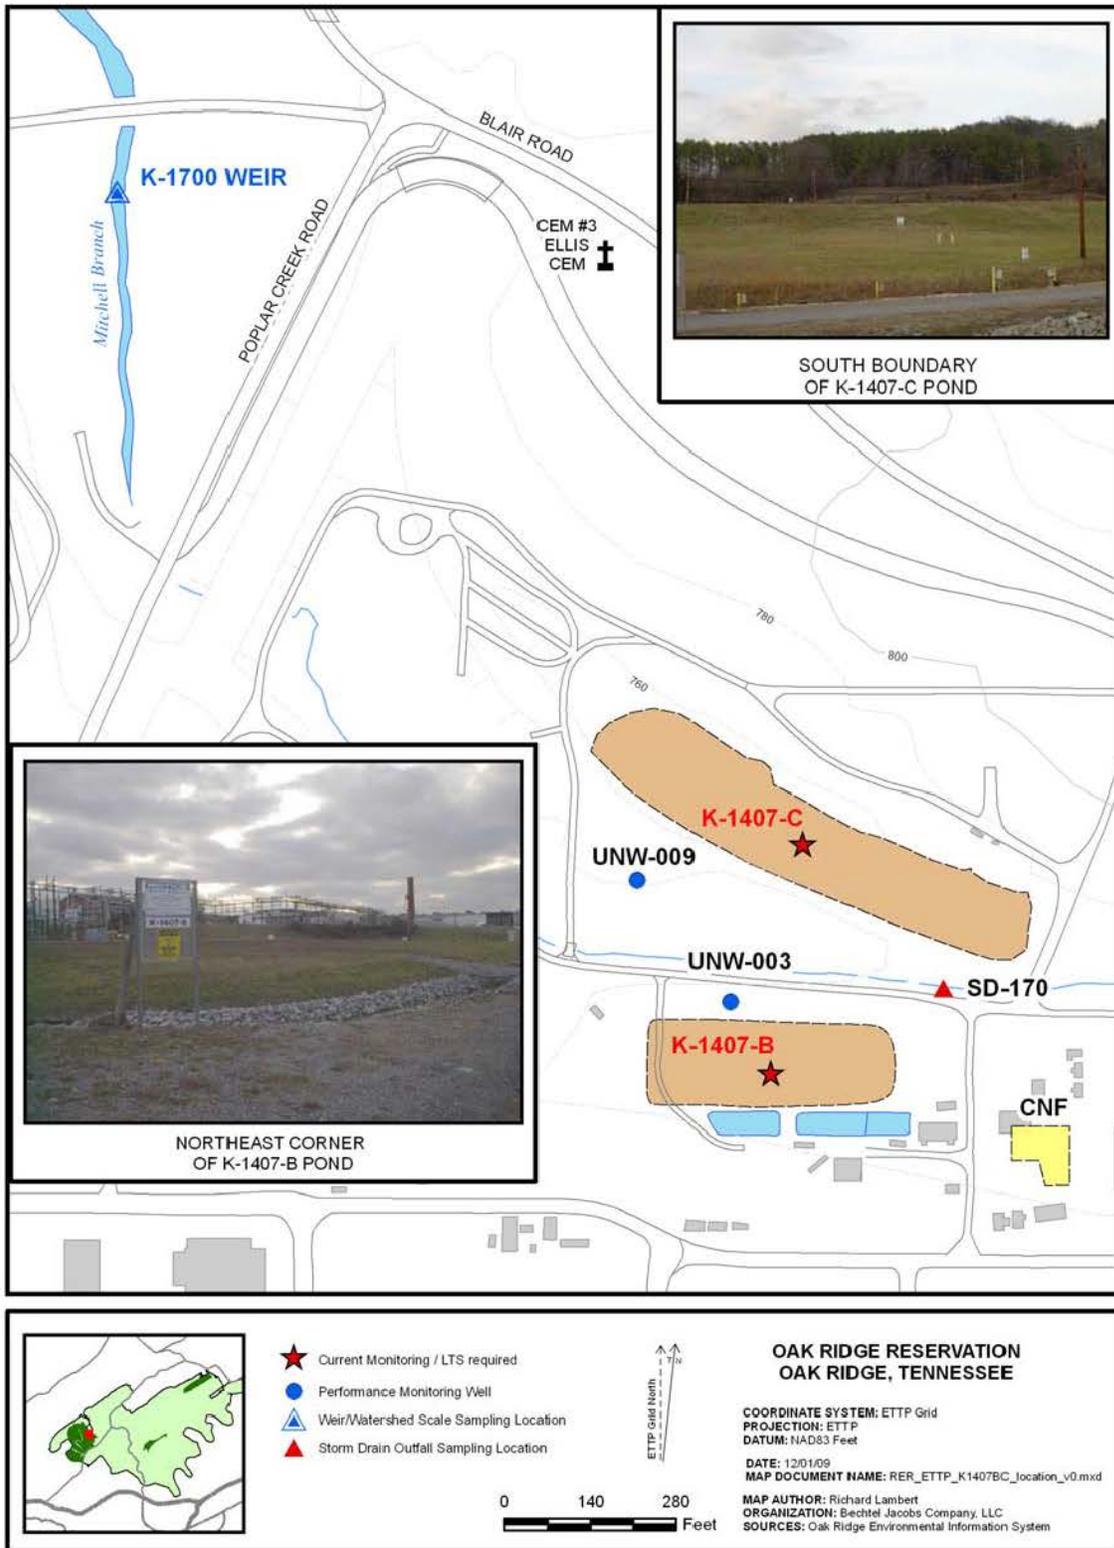
Figure 8.9. Location of K-1407-B/C Ponds.

The *Remedial Action Report for the K-1407-B Holding Pond and the K-1407-C Retention Basin* (DOE 1995a) proposes semiannual groundwater monitoring for nitrate, metals, and selected radionuclides, including gross alpha and beta activity, ^{99}Tc , ^{90}Sr , ^{137}Cs , $^{230,232}\text{Th}$, and $^{234,238}\text{U}$. However, VOCs are the primary groundwater contaminant in the Mitchell Branch area of the ETTP. Remediation target concentrations were not established in the CERCLA decision documents for use in post-remediation monitoring. As recommended by EPA, with concurrence from TDEC, performance monitoring is conducted in wells UNW-003, UNW-009, and the Mitchell Branch weir (K-1700 Weir), shown on Figure 8.9.

During FY 2007, hexavalent chromium was detected in surface water in Mitchell Branch in exceedance of the AWQC (11 µg/L) and was found to be discharging from Outfall 170 (SD-170 on Figure 8.9). In response to this condition, a time-critical removal action was performed to install and operate groundwater seepage collection pumps to capture chromium-contaminated groundwater associated with the Outfall 170 discharge (DOE 2007f; DOE 2008c). Section 8.4.5 reports on the removal action and its associated monitoring. The instream sampling results at MIK 0.71/0.79 for total chromium varied from nondetect levels to maximum of 0.013 mg/L during FY 2011. The maximum hexavalent chromium concentration during FY 2011 was 0.010 mg/L (See Section 8.4.5.2.1).

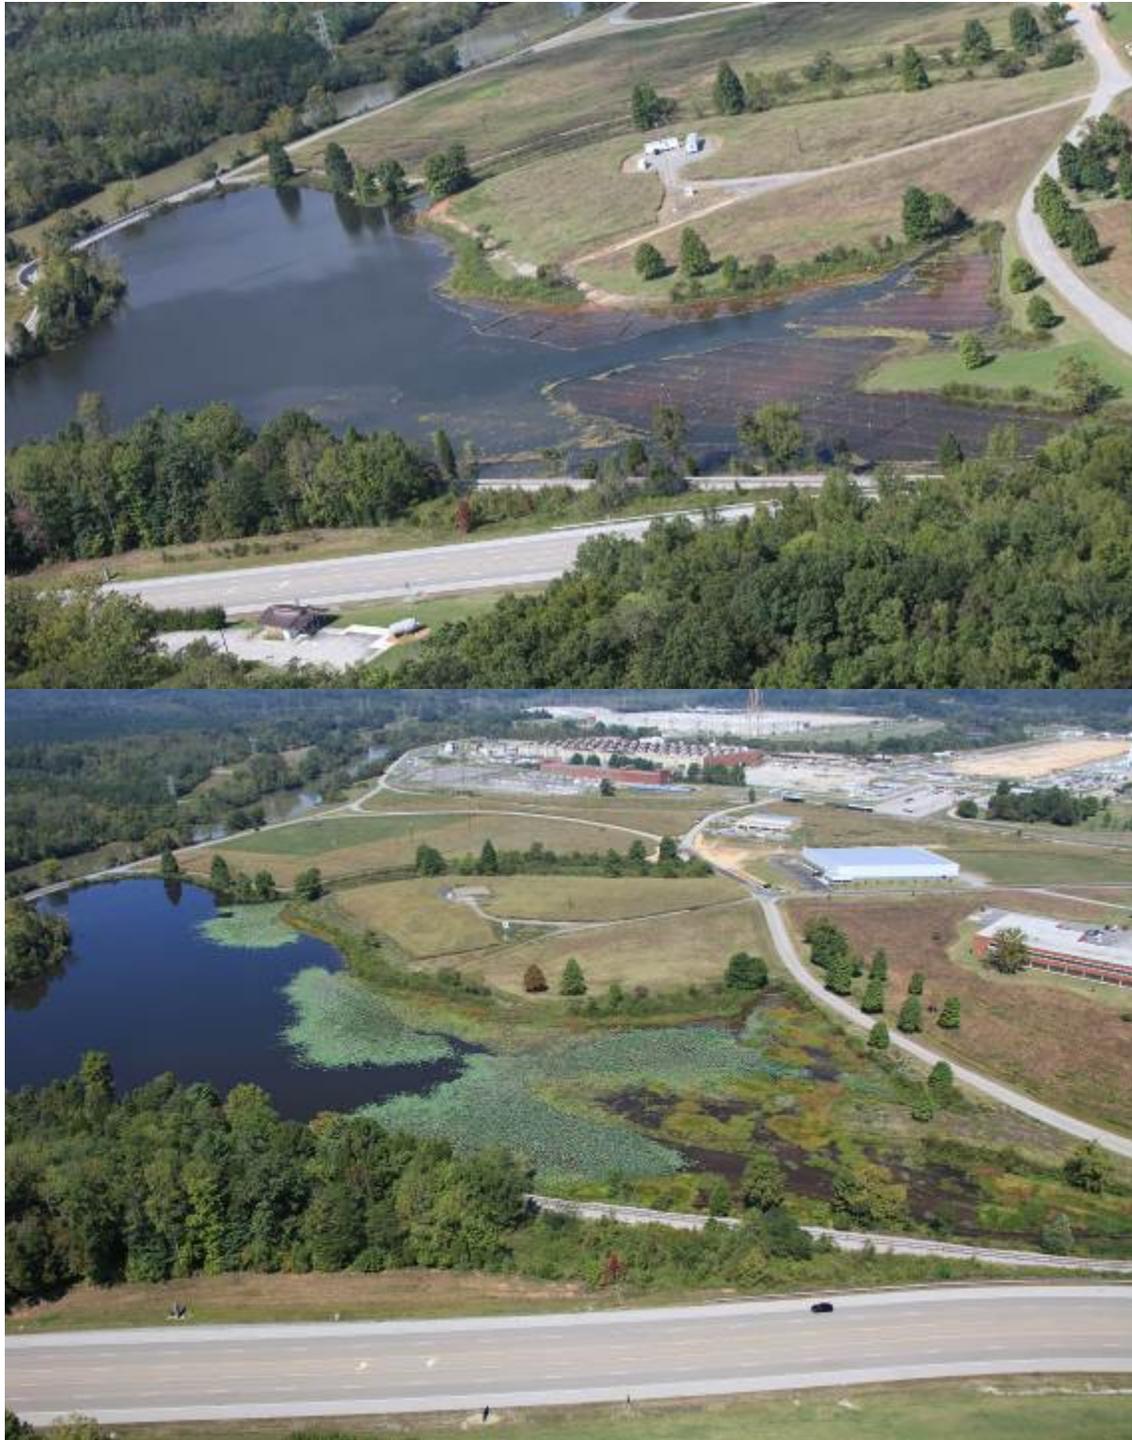
The plant community within the pond has developed substantially since the pond was re-contoured and vegetation planted as part of the removal action. In 2007, the pond was largely devoid of plants except for algae. In 2010-2011, surveys found coverage had increased as much as 7-fold along some transects, although there was variation as a result of temporary water level changes in 2010 (Figure 8.14). The increased coverage was also matched by an increase in plant richness (Figure 8.15) in 2011 that included both species planted during the removal action and volunteer species that may have been present along the periphery of the pond. The establishment of the plant community in the K-1007-P1 Holding Pond is highlighted by aerial photo comparisons between 2009 and 2011 (Figure 8.16).

Figure 8.16. Aerial photos of the K-1007-P1 Holding Pond showing changes in plant coverage between the end of the first year of planting, 2009 (top) and after two growing seasons, 2011(bottom).
